# **COMPLIANCE AUDIT REPORT OF MAFUBE MUNICIPALITY**

**Audit Dates: 27 and 28 November 2012**

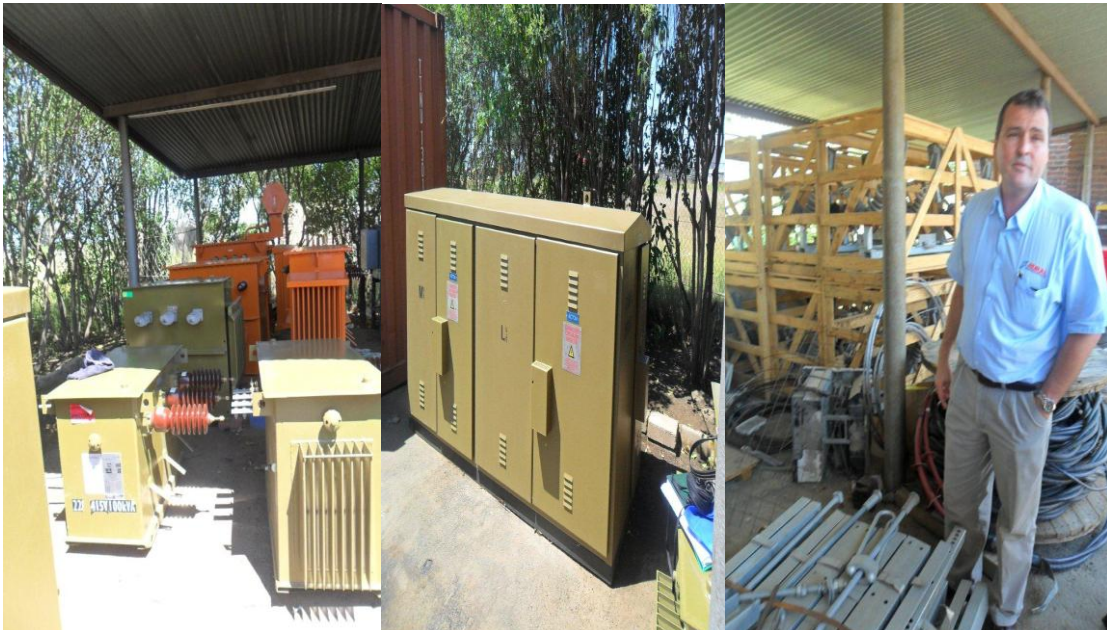
Spares in stores mini sub, transformers, bundle OH conductors and other ancillaries

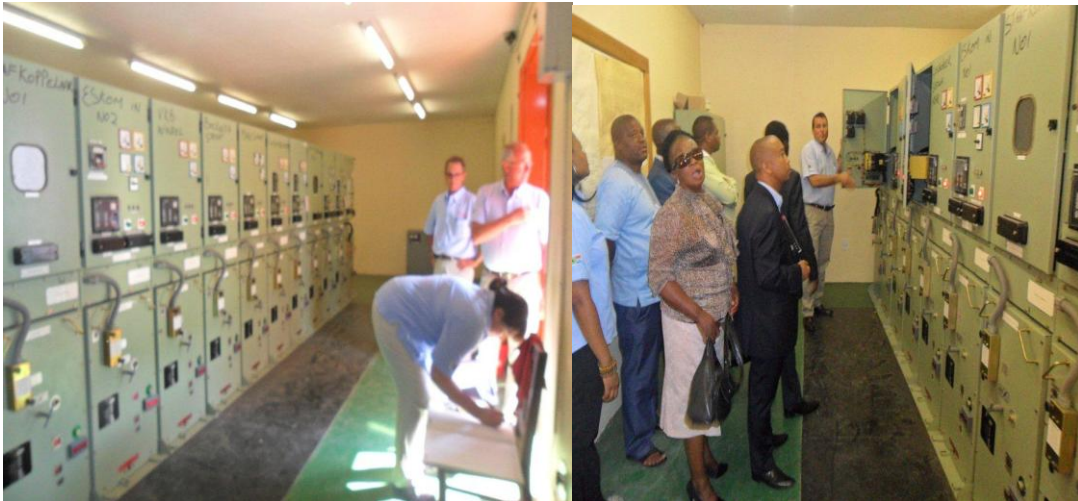
6.6kV Switchgear. The entire indoor switchgear was in good condition and well maintained. All the panels were properly labelled and designated both in the front and back. Panel indicators were functioning properly.

New sf6 Indoor breakers in good condition

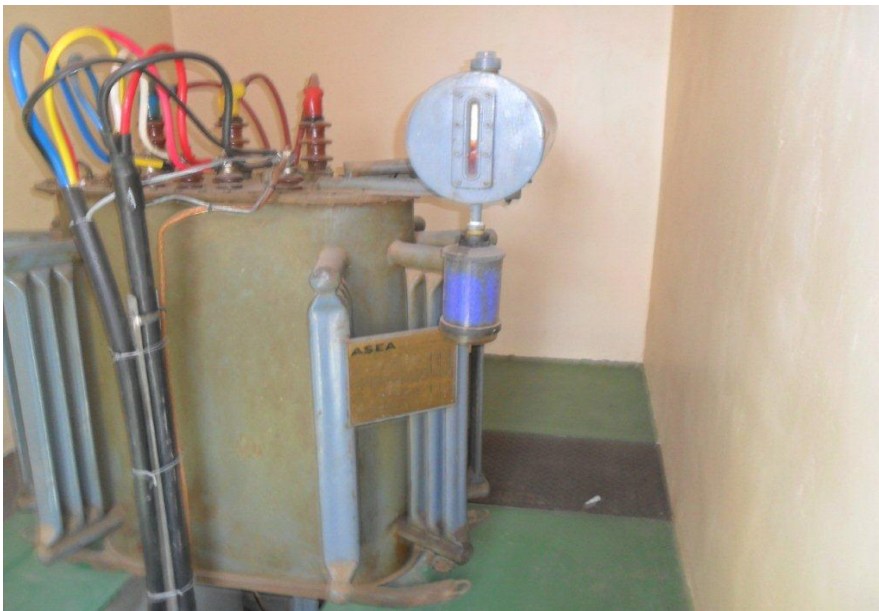
The Local transformer although old (1963) appeared to be in a good condition as no oil leak signs were observed. The silica gel of the transformer was in good condition. Bushings and terminations were in good condition and the earths on the transformer were properly done and intact. The transformer oils levels were acceptable however it was mentioned that this transformer is on a planned maintenance to be done in January 2013.

Local transformer old but was in good condition.

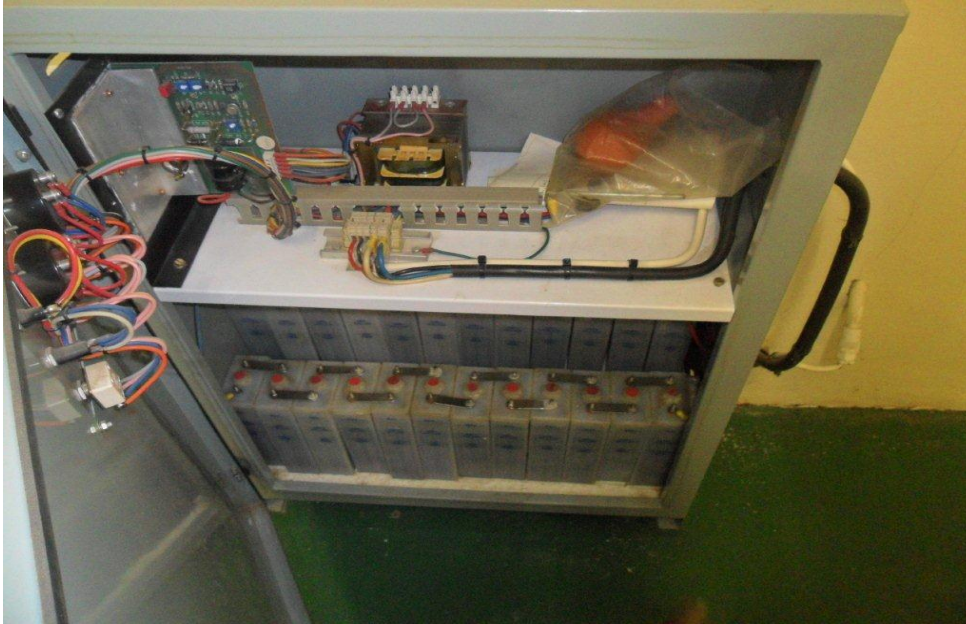
The battery charger was in good working condition and indicators functional. The batteries levels were low need top up as they were below the maximum levels. Battery terminals were in good condition no signs of corrosion or discharge on the terminals.

Battery charger in good condition with low battery levels

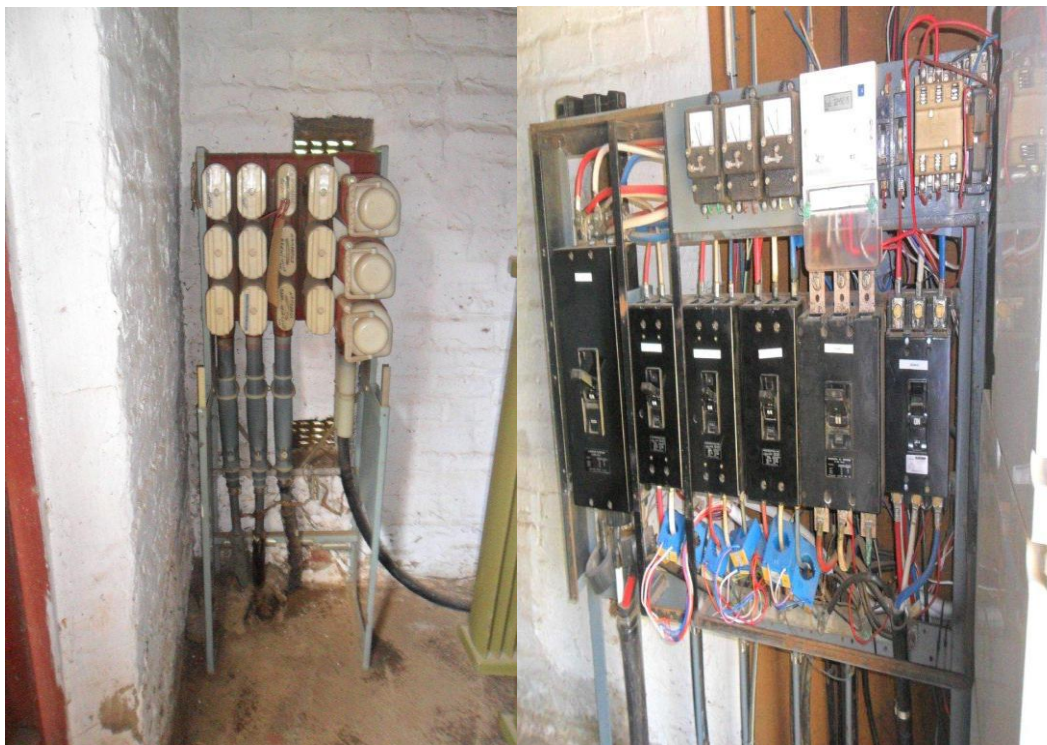
This switch station consists of the old magnefix switch housed in one room with the local transformer and the low voltage (LV) board. This makes switching dangerous on load condition hence switching has to be done upstream with an impact on other unaffected customers should work need to be done in this switch station. The officials mentioned that an order of new 3T switch has been placed and they are waiting delivery in the middle of December 2012 and this will be replaced in January 2013 under the upgrade plan. The LV miniature circuit breaker (MCB) are not housed and mounted in a proper LV board/cabinet however the cables were properly labelled and designated.

Old magenfix switch LV board with MCB mounted against wall on a frame

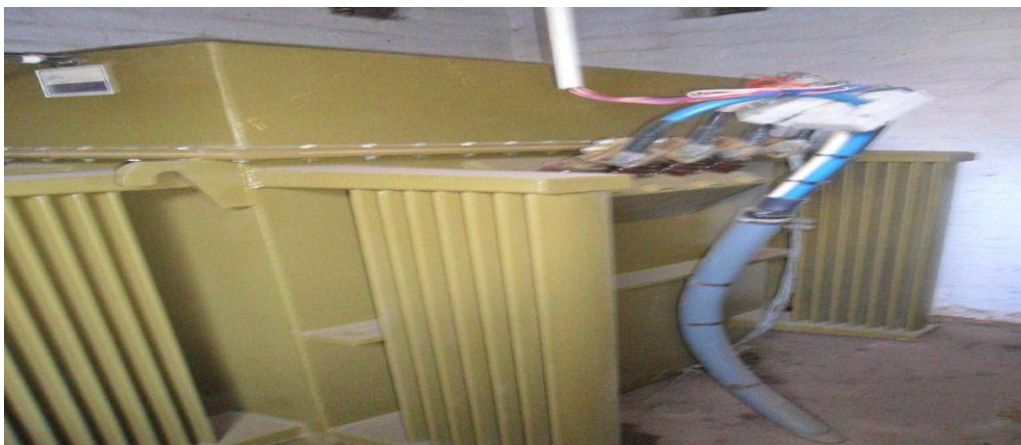
The Local transformer appeared to be in a well maintained condition as no oil leak signs were observed. The silica gel of the transformer was in good condition. Bushings and terminations were in good condition and the transformer earths were properly done and intact.

Transformer in good condition

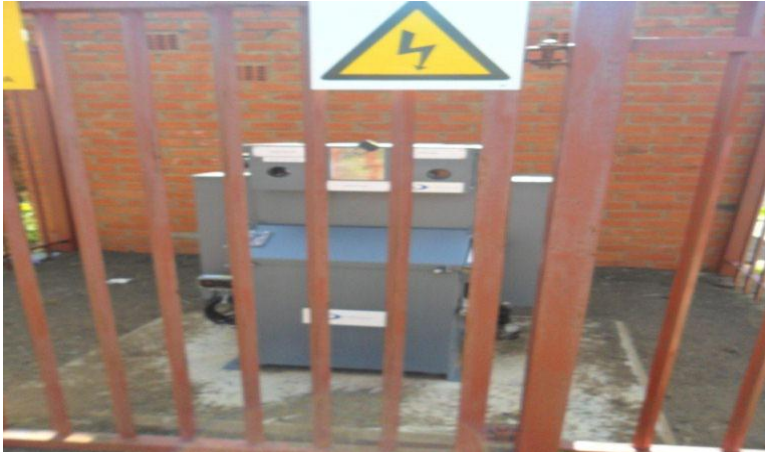
The danger and safety signage on the door were available and in good condition for public warning and safety. This switch station was upgraded from the old magnefix switch to the new compact T3 switch. During the upgrade the T3 switch was relocated outside the building to allow space and safety during operation. The switch is properly earthed, designated and locked with a pad lock to prevent unauthorised operation. In addition to this protection it is well fenced with a palisade having warning sign to the public.

New T3 switch on cement plinth inside barricade with warning sign

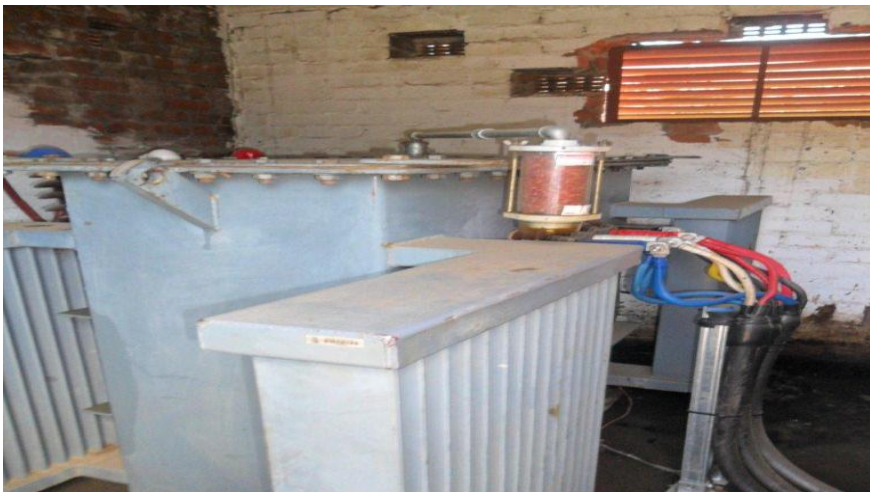
The Local transformer room showed signs of oil contamination from a previous faulty transformer and this needs to be remedied. The silica gel was also in a bad condition need replacement. Transformer earths, bushings and terminations were intact and in good condition.

Old silica Gel

- j) Old silica gels must be replaced.
- k) The upgrade projects of the MV and LV network must be pursued to conclusion.
- l) Power Quality systems must be fully commissioned.

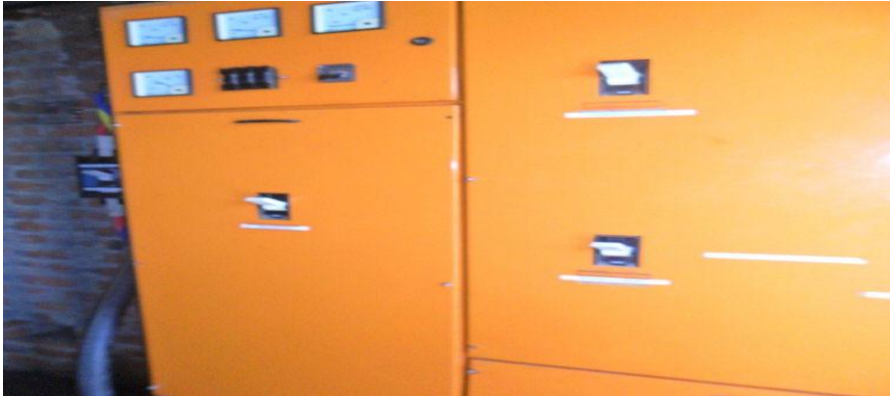
The LV miniature circuit breaker (MCB) are housed and mounted in a proper LV board/cabinet and were properly labelled and designated. The LV

transformer Main Circuit Breaker (MCB) was mounted against the wall this must also be housed in a proper panel.

MCB mounted against the wall next to proper panel with designated LV MCB

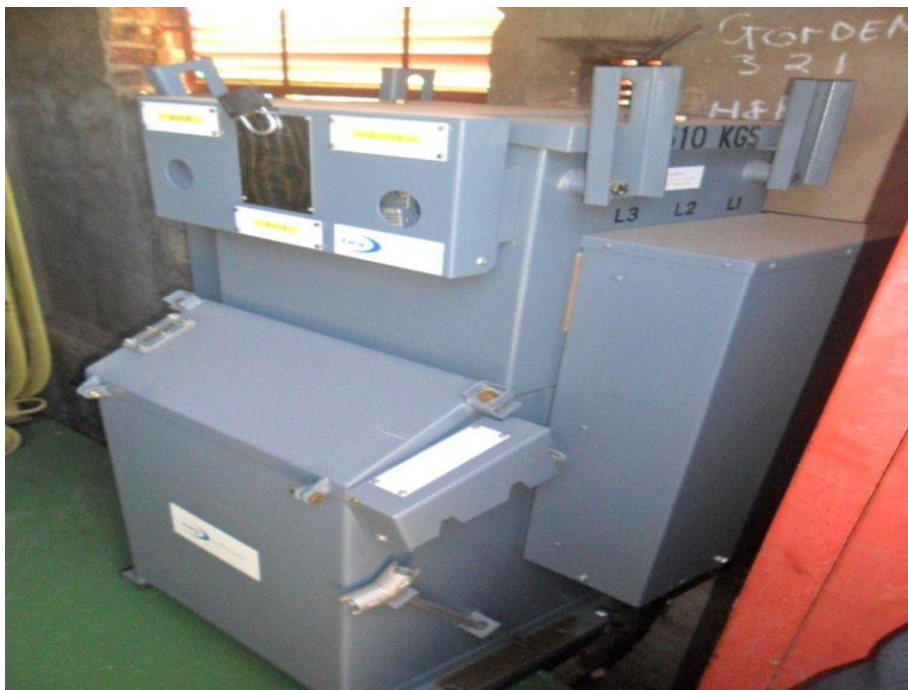
There were danger and safety signage available and displayed at the door of the switching station. The signage and warning signs were in good condition for public warning and safety. A portion of this switch station was upgraded from the old magnefix switch to the new compact T3 compact switch. The T3 switch is properly earthed, designated and locked with a pad lock to prevent unauthorised operation.

New T3 switch in good condition

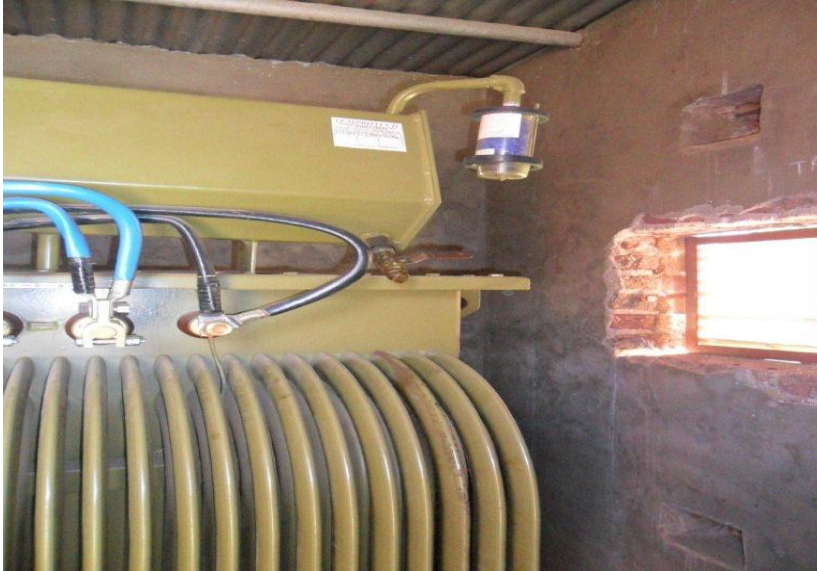
The Local transformer appeared to be in a well maintained condition as no oil leak signs were observed. The silica gel of the transformer was in good condition. Bushings and terminations were in good condition and the transformer earths were properly done and intact.

Transformer and silica gel in good condition

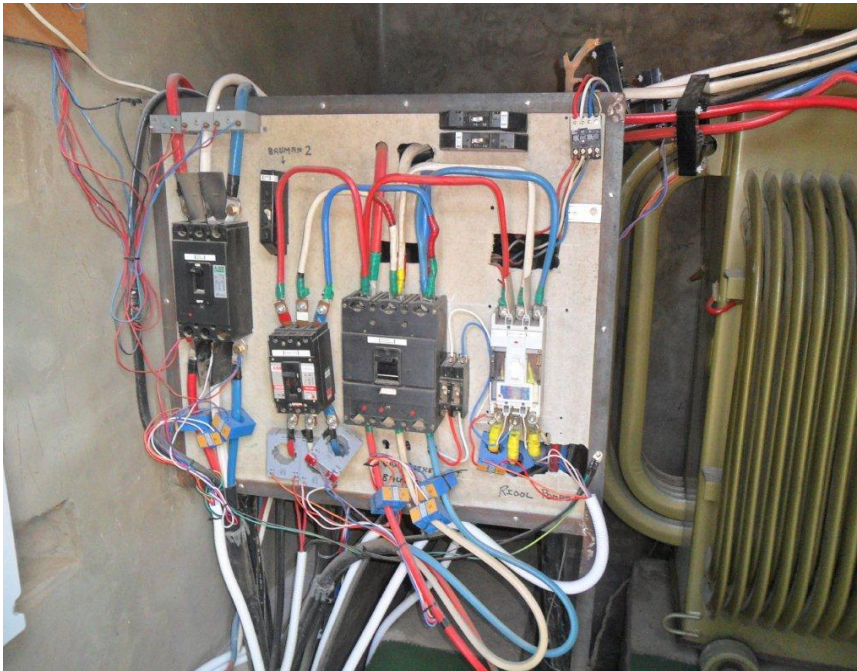
The LV miniature circuit breaker (MCB) were not housed and mounted in a proper LV board/cabinet although labelled and designated. These LV MCBs need to be put into a proper LV board/cabinet.

LV MCBs mounted on a frame.

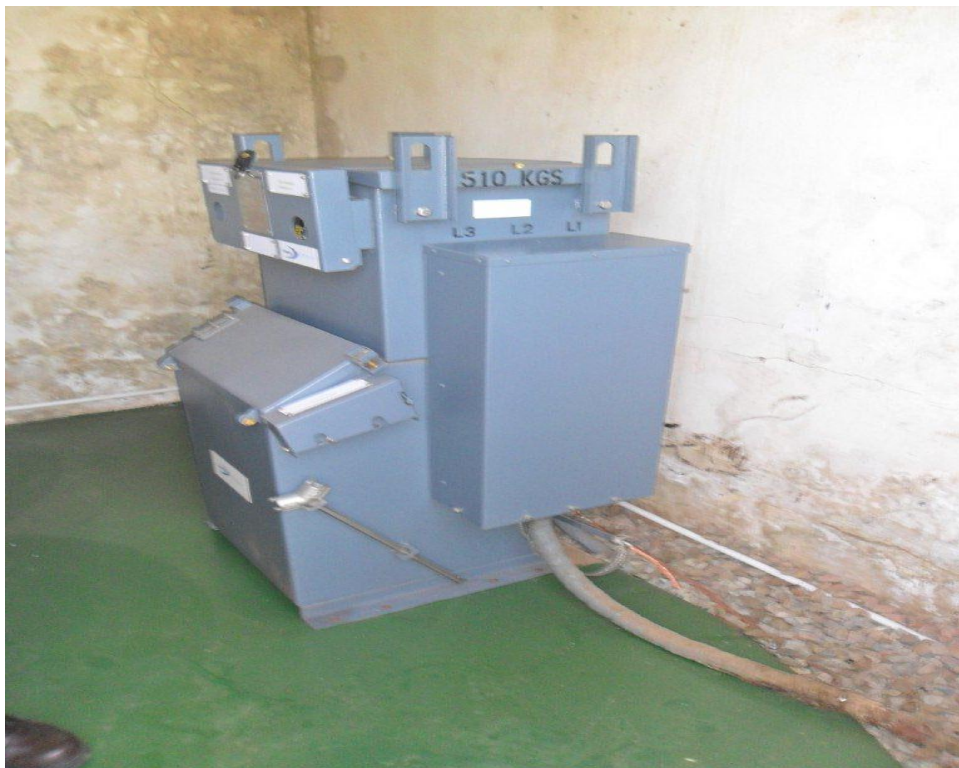
There were danger and safety signage available and displayed at the door of the switching station. The signage and warning signs were in good condition for public warning and safety. The switch station was upgraded from the old magnefix switch to the new compact T3 switch. The T3 switch is properly earthed, designated and locked with a pad lock to prevent unauthorised operation.

New T3 switch in good condition

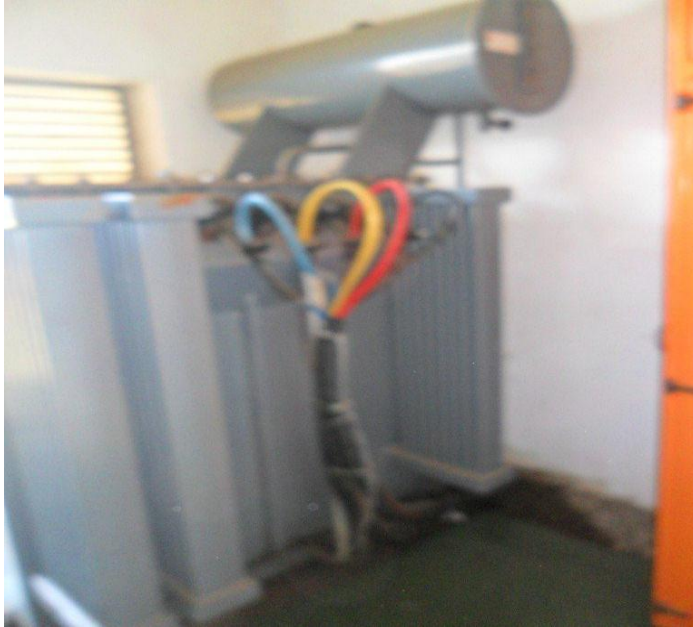
The Local transformer appeared to be in good condition as no oil leak signs were observed although it was last serviced in 2009. The transformer oil was in an acceptable level. The silica gel of the transformer was in an acceptable condition. Bushings and terminations were in good condition and the transformer earths were properly done and intact.

Transformer and silica gel in good condition

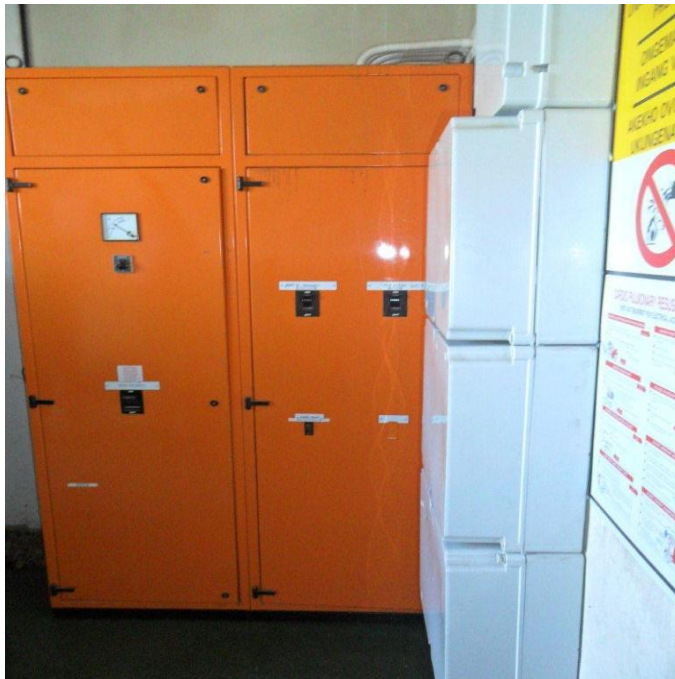
The LV miniature circuit breaker (MCB) were housed and mounted in a proper LV board/cabinet with proper labels and designations. The LV board/cabinet is still in good condition.

LV MCBs cabinet in good condition and properly labelled.

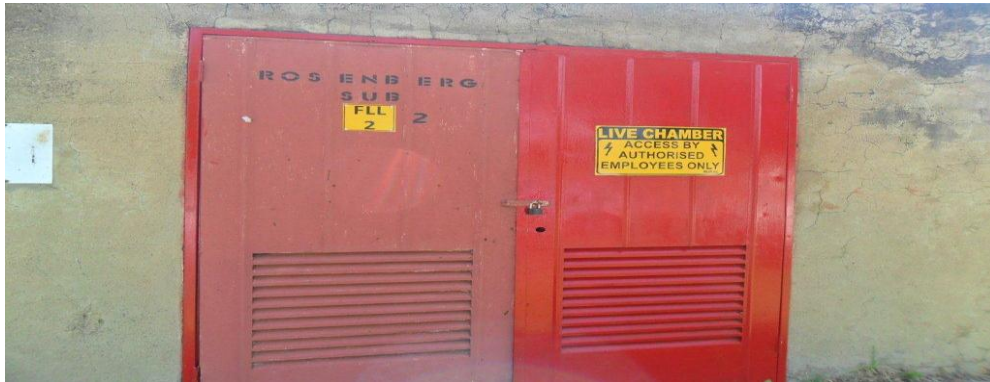
There were danger and safety signage available and displayed at the door of the switching station. The signage and warning signs were in good condition for public warning and safety. The switch station was upgraded from the old magnefix switch to the new compact T3 switch. The T3 switch is properly earthed, designated and locked with a pad lock to prevent unauthorised operation.

Switching station with warning signs to public properly locked

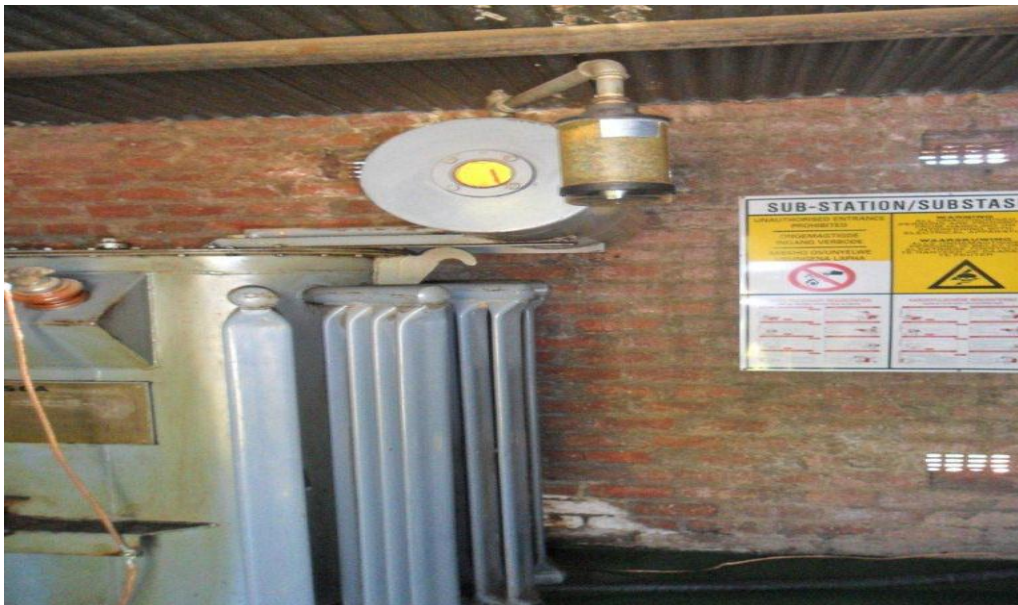
The Local transformer was not in good condition as signs of oil leaks were observed however the transformer oil was in an acceptable level. The silica gel of the transformer was in bad condition need replacement. Bushings and terminations were in good condition and the transformer earths were properly done and intact.

Transformer and silica gel in good condition

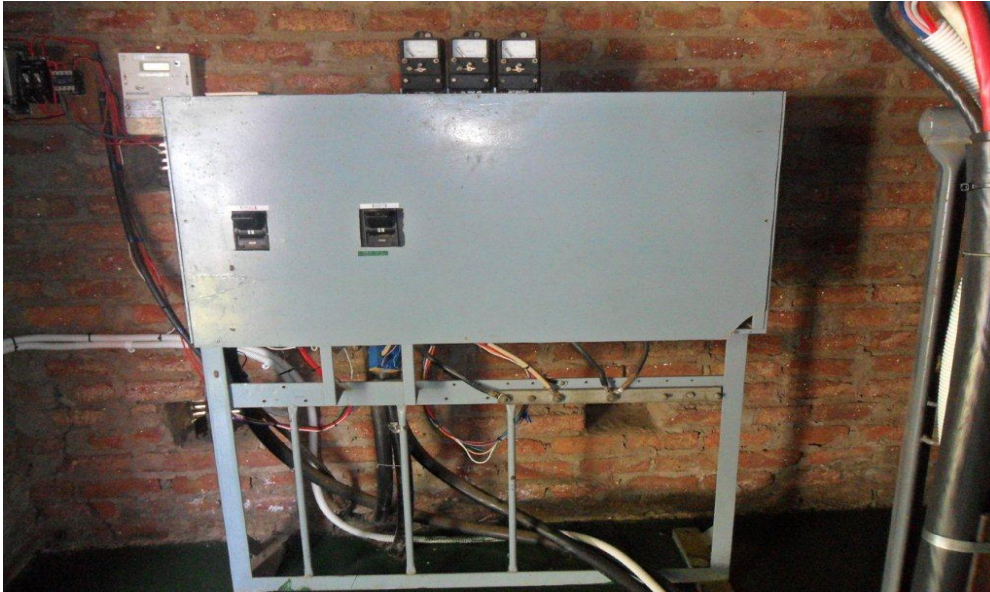
The LV miniature circuit breakers (MCB) were mounted against the wall and some were housed and mounted in processed wood chipboard a material that catches fire easy. The MCB against the wall were not labelled or designated proper. The LV board/cabinet need to be replaced and all MCBs must be housed in a proper LV panel.

LV MCBs board made of chipboard and other MCB against the wall.

- h) The maintenance and refurbishment plan available must be updated to be able to monitor or keep track of what is done and what is outstanding.
- i) Sub standard LV boards must be replaced with proper LV boards.

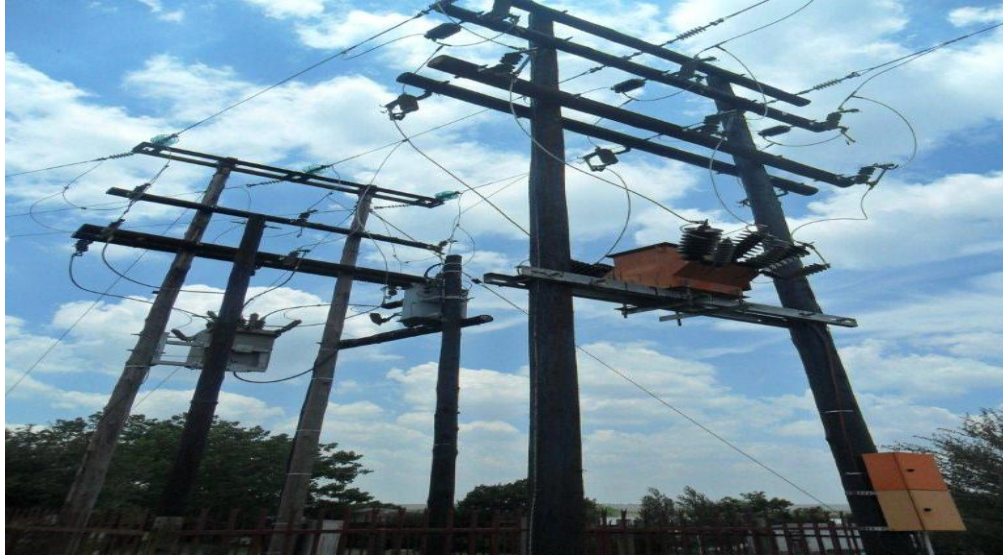
Cornelia is feed from Eskom through a Current Voltage combination transformer (CTVT). The line supplying the unit was upgraded from 11/22Kv and new pole structures were installed on the line during the upgrade. The CTVT unit was properly secured on an HT pole on top of a proper steel cross arm. The unit was properly earthed, terminations properly done. Jumpers and insulators on the structures were intact and properly done. Surge arrestors were in place and in good condition. The line was protected by means of an auto recloser (ARC) for immediate/automatic restoration of power under fault conditions. The recloser was also in a good condition in the same state as the CTVT unit and well barricaded by means of a palisade fence.

CTVT unit with an Auto Recloser at Cornelia.

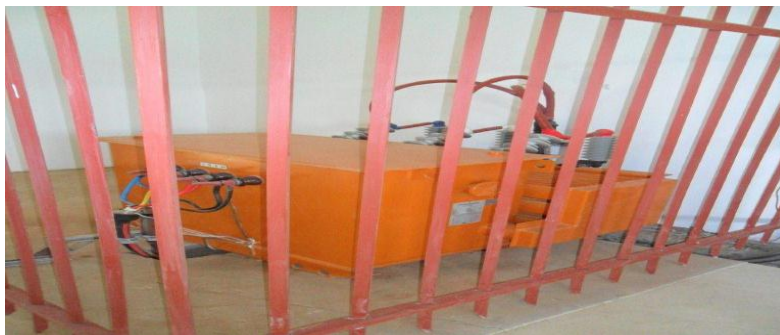
There were danger and safety signage available and displayed at the door of the main substation. The signage and warning signs were in good condition for public warning and safety. The old local transformer in the station was replaced with a new properly barricaded 315kVA transformer. This transformer was in good condition as no signs of oil leaks were observed. The surge arrestors were in good condition and silica gel of the transformer was also in good condition. Bushings and terminations were new in good condition and the transformer earths were properly done and intact.

New transformer and silica gel in good condition with surge arrestors

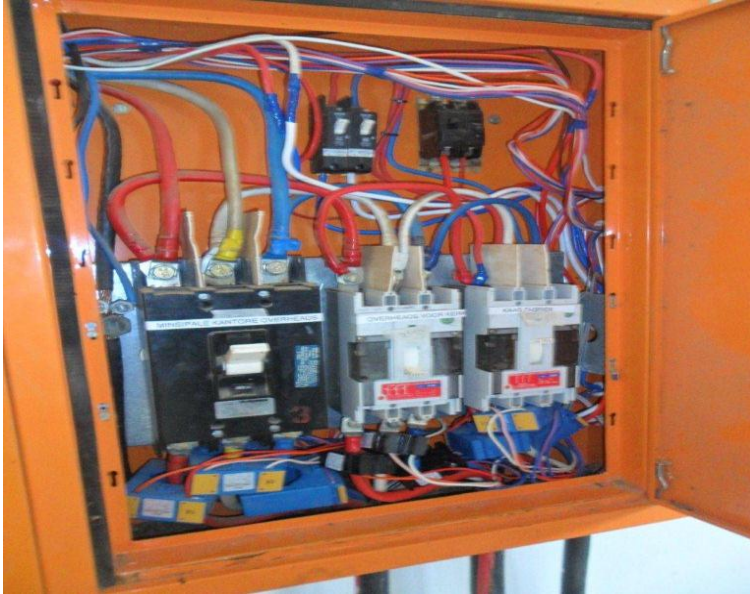
The LV miniature circuit breakers (MCB) were mounted against the wall and some were housed and mounted in processed wood chipboard a material that catches fire easy. The MCB against the wall were not labelled or designated proper. The LV board/cabinet need to be replaced and all MCBs must be housed in a proper LV panel.

Proper LV MCBs cabinet in good condition and properly labelled.

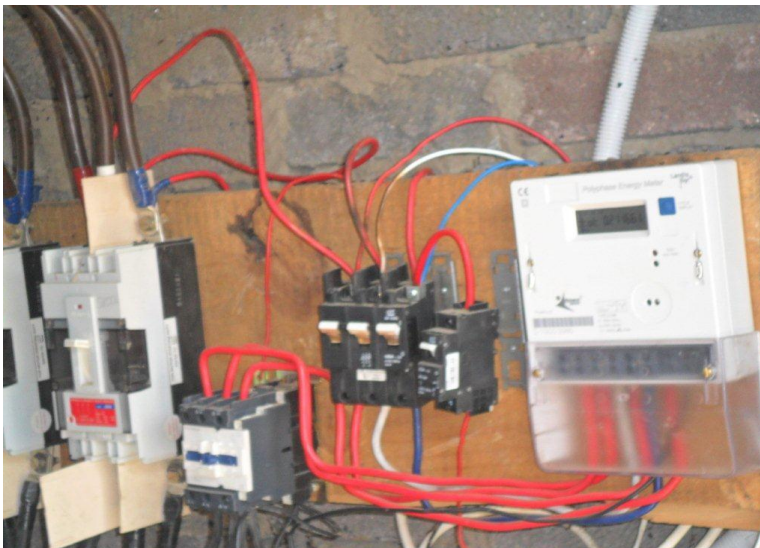
The signage and warning signs were in good condition for public warning and safety. In this substation LV MCBs were exposed and attached on a wooden plank instead of a proper LV cabinet. Also the MCBs were not properly labelled and designated. This setup needs replacement urgently as it is substandard and a potential hazard.

LV MCBs mounted on a wooden plank with no designations

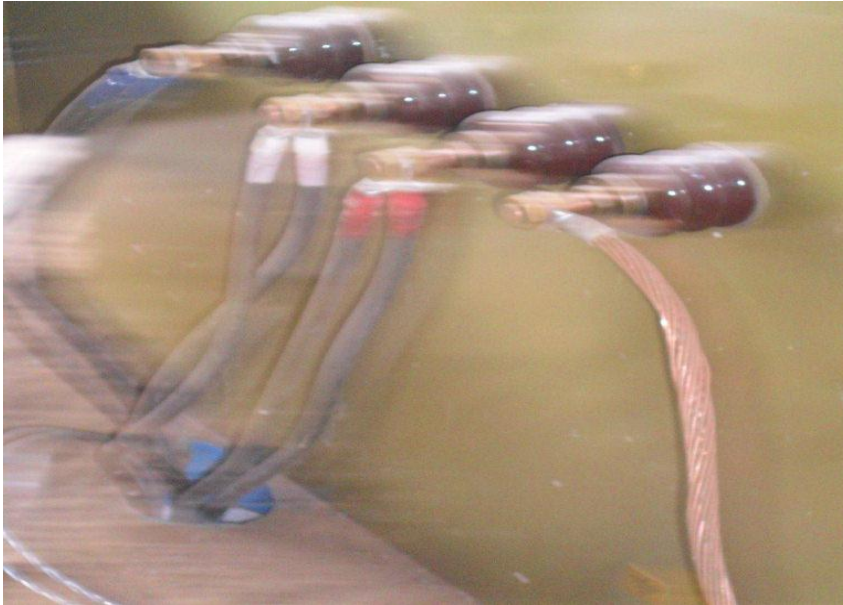
The transformer inside the room appeared to be in good condition however it was not on a proper plinth. There were no signs of oil leaks observed. Bushings and terminations were in an acceptable condition and the transformer earths were properly done and intact.

Local transformer in good condition

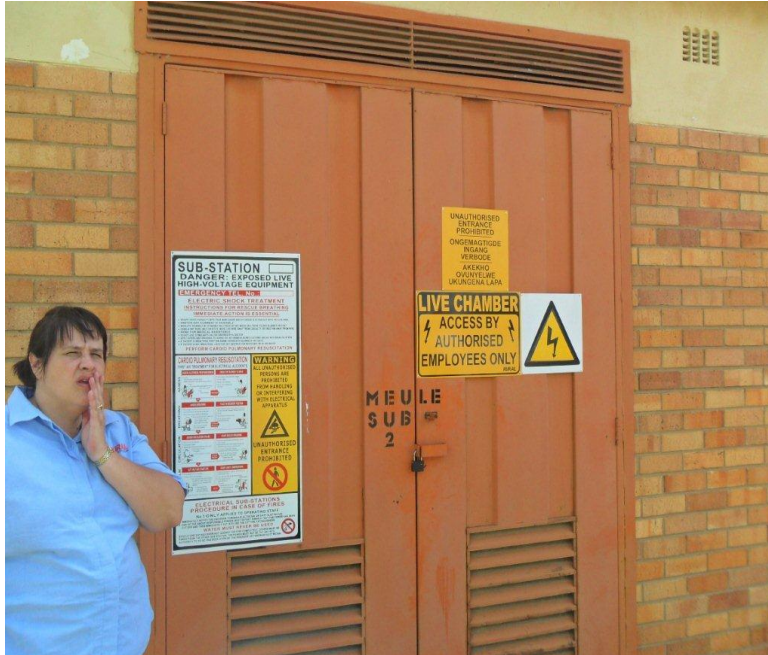
There were danger and safety signage available and displayed at the door of the substation. The signage and warning signs were in good condition for public warning and safety. The switch station was upgraded from the old magnefix switch to the new compact T3 switch. The T3 switch was properly earthed, designated and locked with a pad lock to prevent unauthorised operation.

Switching station with warning signs to public properly locked

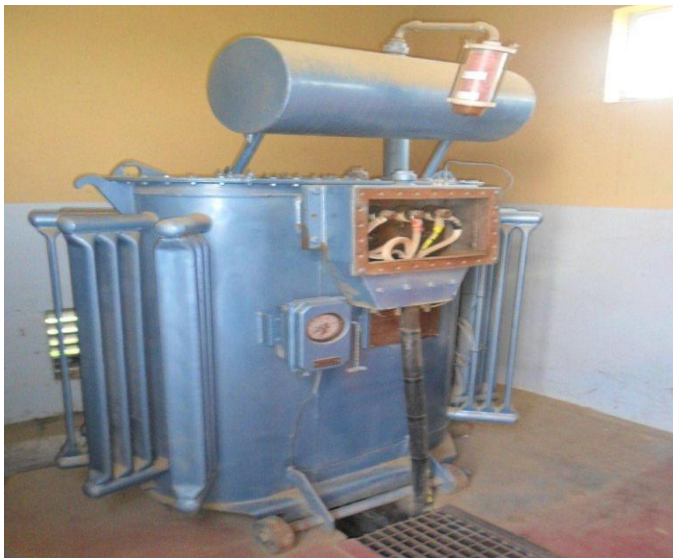
The Local transformer's oil was in an acceptable level however the transformer was not in good condition as the LV terminal plate cover was missing and opened. The silica gel of the transformer was in bad condition need replacement. The HV bushings and all terminations were in good condition and the transformer earths were properly done and intact. Proper cable trench and trench covers were in place and in good condition.

Transformer and silica gel in good condition

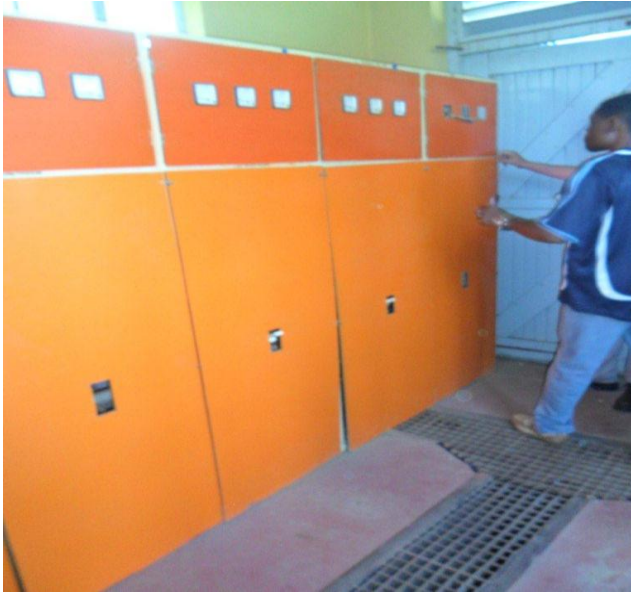
were also not properly labelled. The LV board/cabinet need to be replaced and all MCBs must be housed in a proper LV panel and labelled accordingly.

LV MCBs board made of chipboard and not properly labelled.

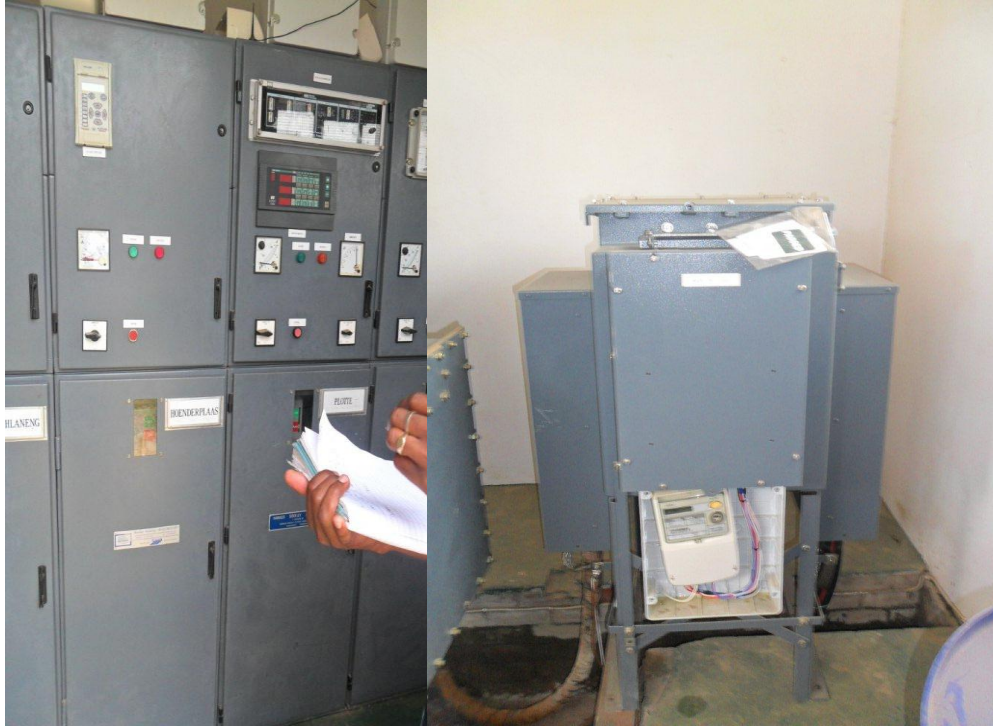
These breakers were in good working condition and well maintained. There were no signs of oil leaks and all panels were properly labelled both in front and at the back. All panel indicators were in working conditions as breaker status could be read on the breakers. According to the officials the protection relays grading was just concluded and the relays were in good working condition.

Indoor oil breaker in good condition with and compact T3 switch

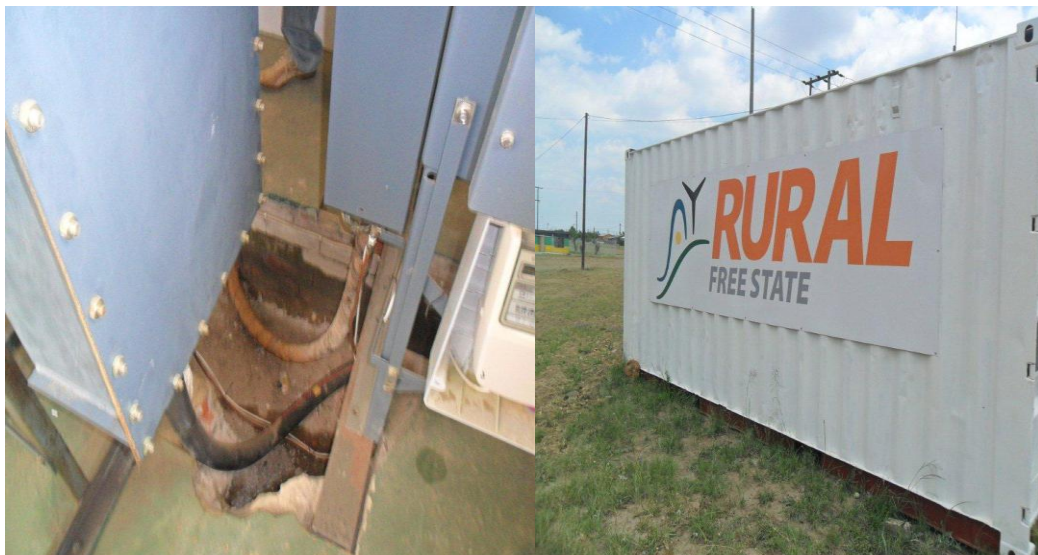
Fire extinguisher was in its designated area and still valid. The general condition of the building and housekeeping in the switch room was not good as cable trenches were opened there were no trench covers also the room was used as a store room as drums and containers of oil were lying in the room. As this was pointed out the officials indicated that the container outside is in a process to be established and this will serve as the stores and site office. It was also mentioned that the building will be in a process to be cleaned once the store room is fully commissioned.

Open cable trenches

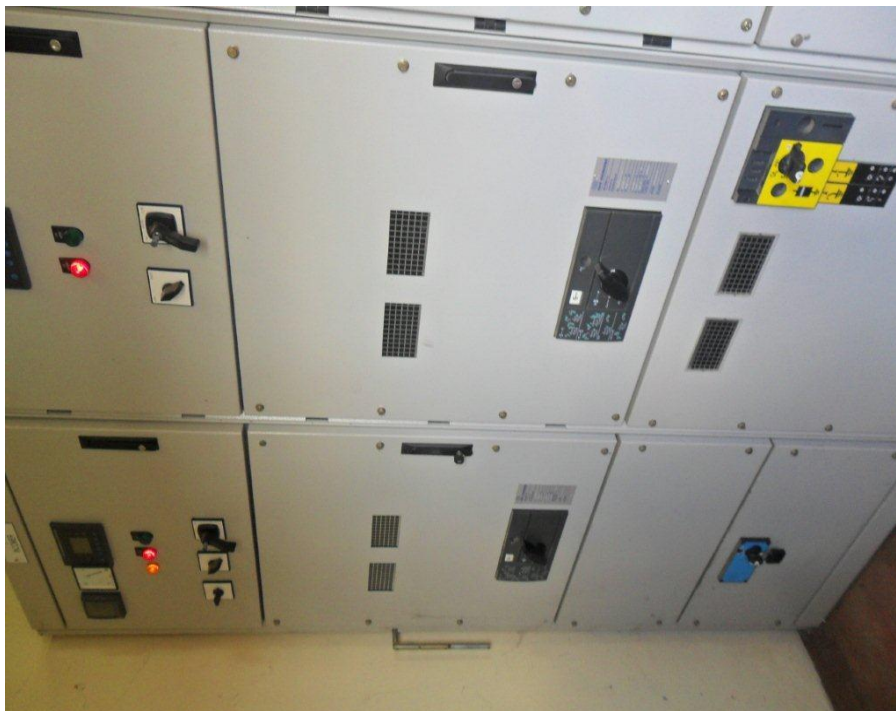
These breakers were in good working condition and well maintained. There were no signs of neglect. One of the breakers was not in service due to its parts being used to fix another breaker that experienced a fault in the past. This breaker must be repaired urgently as there is currently no spare breaker available. All panel indicators were in working conditions as breaker status could be read on the breakers.

Indoor breaker in good condition with

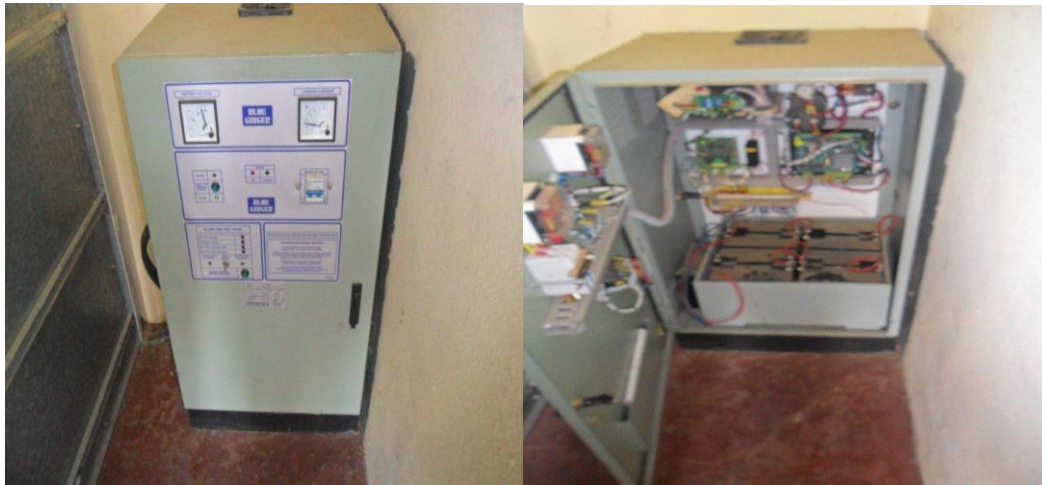
The backup system was in good working condition. The battery charger was well maintained and all indicators were working. The solid state/ dry cell type batteries were also properly placed inside the charger.

Battery charger with dry cells inside all in good condition

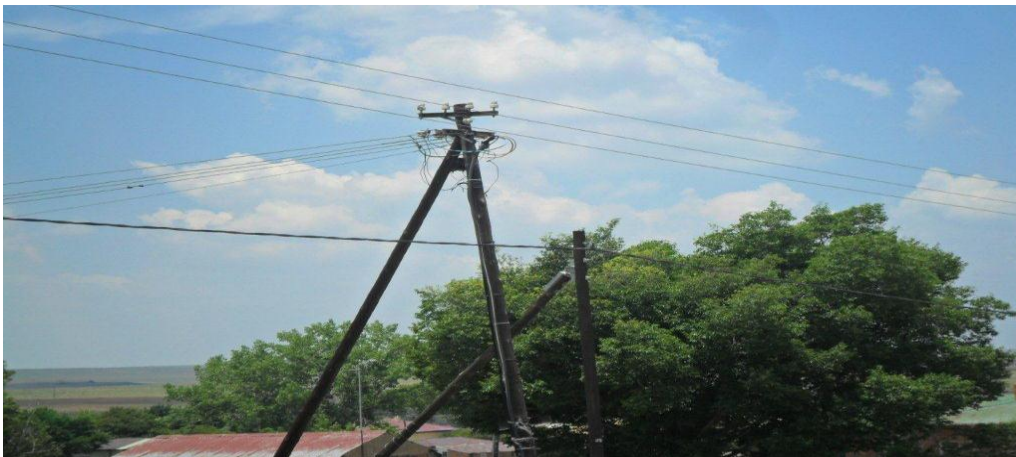
In Villiers there was a problem with trees coming into contact with lines and a project was already far underway to cut the trees under the lines and to also upgrade and convert the LV line from three phase bare wire LV lines into bundle conductors LV lines in order to reduce the risk of trees causing faults on the lines. The project was still in progress about 45% of the network was upgraded at the time of the audit. Proper stringing and tensioning was done on the lines. As the MV and LV lines shared the same servitude proper and correct clearances were maintained between the MV and LV lines. Also some new poles were installed and connected to a portion of the MV line where old poles were removed. Also jumpers, insulators and terminations were installed accordingly.

LV line upgraded with new poles & bundle conductor correct clearances between MV and LV line

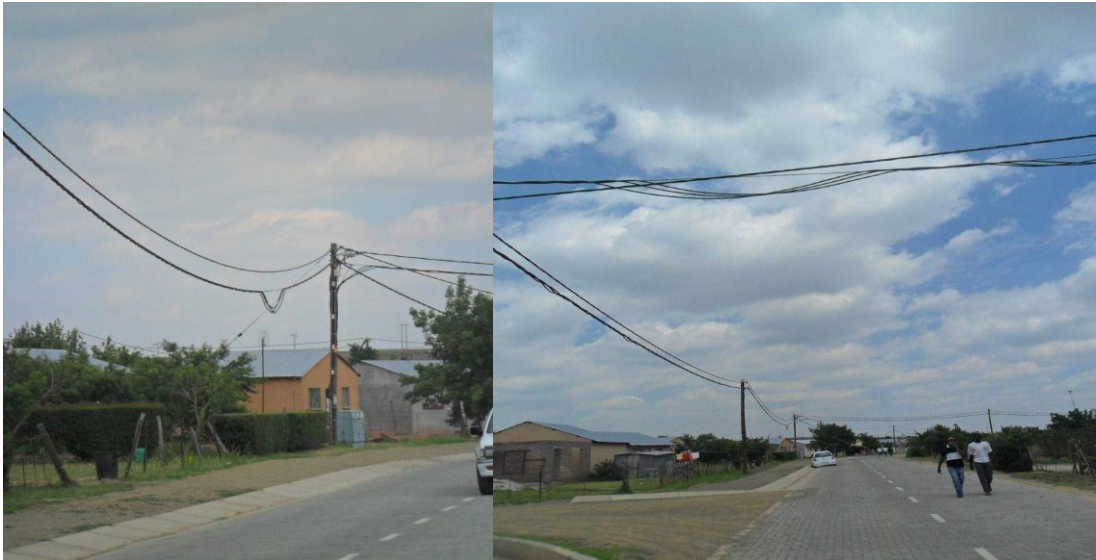
At Tweeling Township the network was inspected and this was found to be a sub standard network. This is made up of twisted bundle conductors where an MV line and an LV line share the same pole structure which is normal. The only problem found to be prevalent on this network was the situation where the MV line was running below the LV line.

Also the clearance between the MV and LV lines were found to be non standard as they were very close to each other. This necessitate an outage even if a minor work has to be done on the LV line since the LV line is running above the MV line as a result other customers tends to be affected unnecessary due to outages and this will have a negative impact on the availability of continuous supply to customers i.e. system availability duration index (SAIDI). This is already part of Rural Freestate's normalisation plan. In some areas the conductors were falling off the anchor wire.

MV line above LV line no adequate clearance in some places conductors falling off the anchor wire.

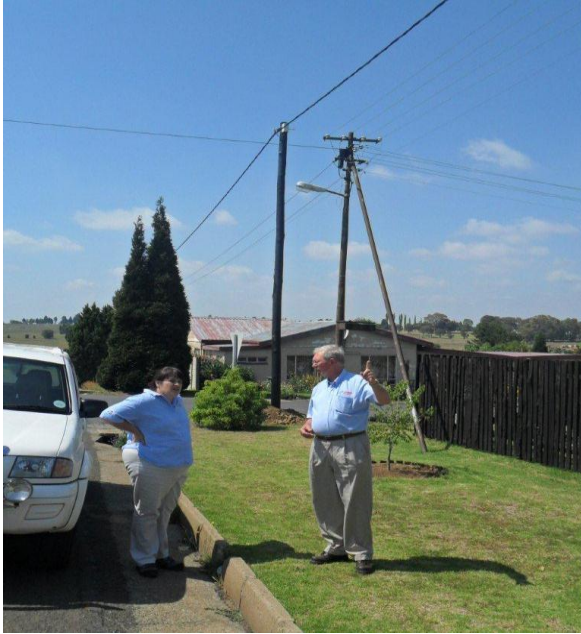
At Frankfort some old overhead LV lines were undergoing an upgrade during the audit. The old steel poles were being replaced with new wooden poles, the three phase bare wire copper conductors were being replaced with bundle conductors and line spacing was also done to prevent phase clashing under wind condition as this was a problem in some portion of the network. The officials mentioned that the project is still carrying on as some poles were observed where the cable work was still to be done.

New LV bundle line installed

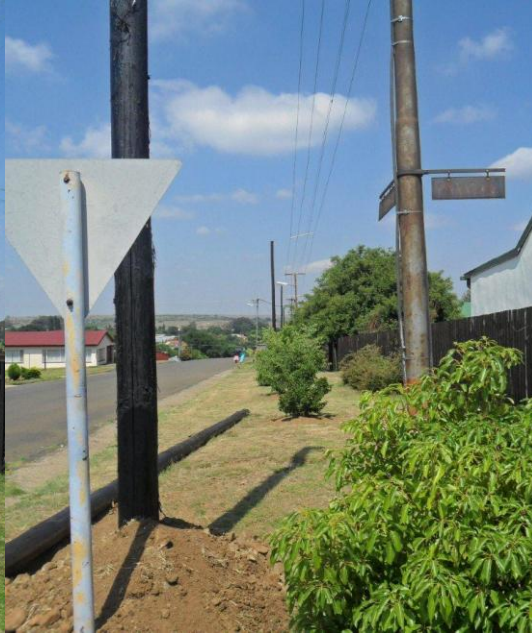
LV poles installed in a process to upgrade line

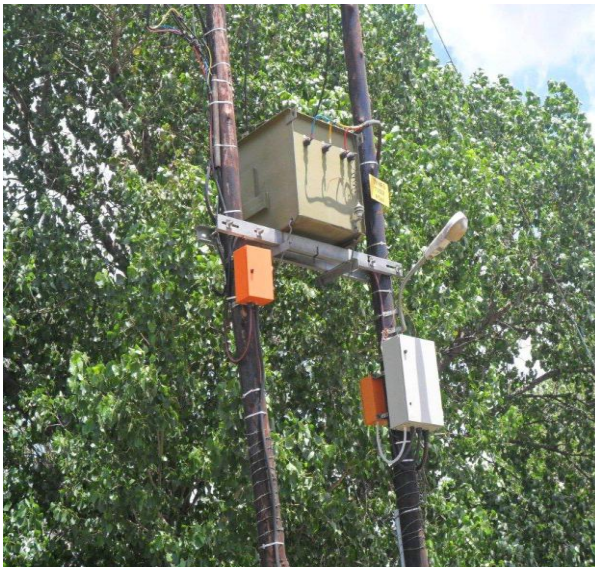
A sample of pole mounted transformers was inspected. These were only in Villiers, Tweeling Township and Cornelia. The entire pole mounted transformers inspected were found to be in good condition. The earthing was intact. There were no oil leaks, transformer bushings and surge arrestors were in good conditions. The jumpers, insulators, cable terminations and insulations were properly done. The condition was generally good.

Pole transformers at Villiers in good condition with coms

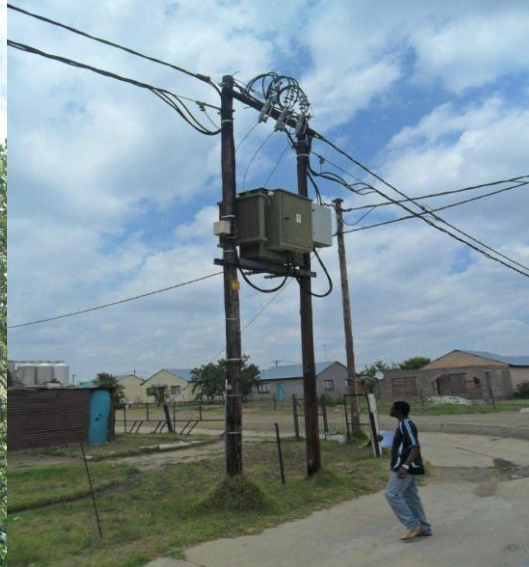
Pole transformer in Tweeling in good condition

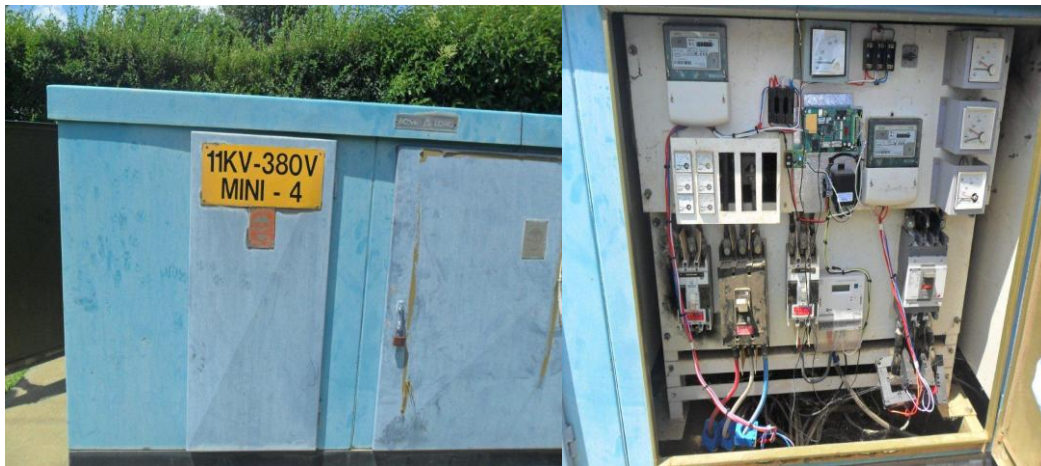
A sample of mini substations (MSS) was inspected at Villiers and the mini substations inspected were found to be in an acceptable condition. All mini substations were secured and put on proper concrete plinths. The inspected MSS were properly locked and well earthed. Only small vegetation growing next to the water works MSS was observed and this need to be attended to before it overgrow the MSS. The MV compartment of MSS 4 was properly designated while the LV side was not properly done to designate cables. This needs to be corrected to ensure that the correct circuit is switched off should a need arise. In addition to this, warning and safety signage was fading and need replacement.

Mini substation on proper plinth

MSS with proper locks
